RESERVE STUDY

Scofield Residential Owners Association

Austin, Texas

May 7, 2021

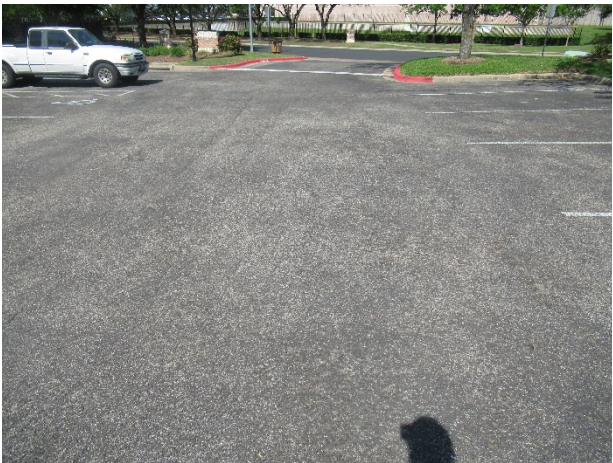
Condition: Fair overall with cracks and deteriorated asphalt

Overview of parking area

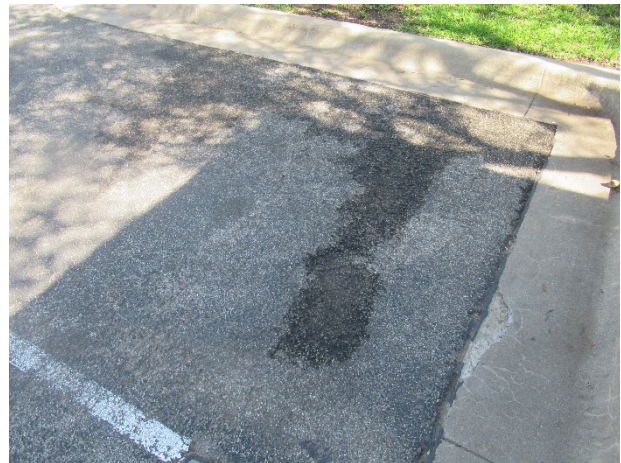
Concrete deterioration

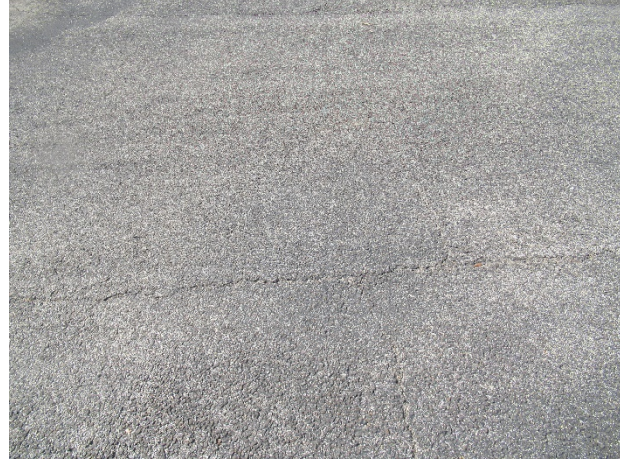
Transverse and longitudinal cracks

Expenditure Detail Notes: Expenditure timing and costs are depicted in the **Reserve Expenditures** table in Section 3. Our cost for milling and overlayment includes area patching of up to ten percent (10%). This cost estimation includes repairs and partial replacements to the curbs.

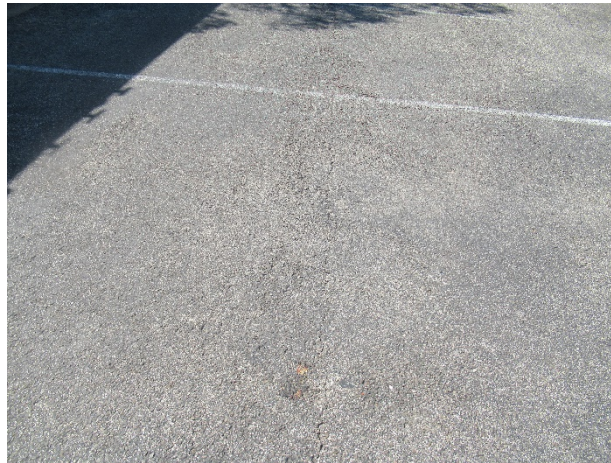
Deteriorated asphalt

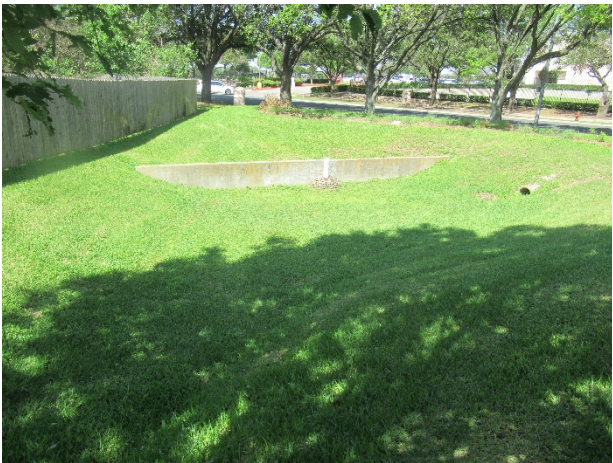
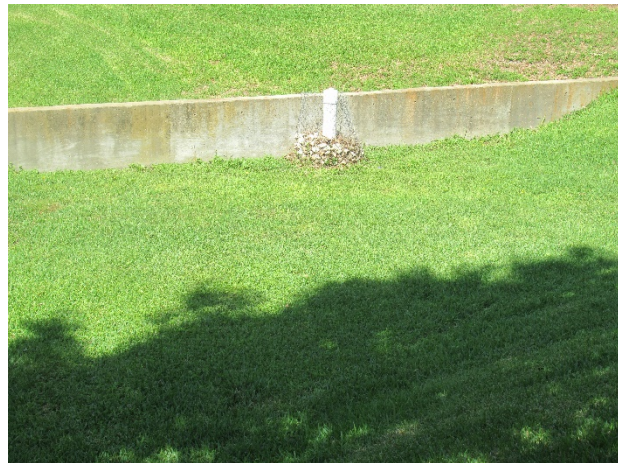
Condition: Good overall

Overview of filtration basin

Filtration basin

Expenditure Detail Notes: Expenditure timing and costs are depicted in the **Reserve Expenditures** table in Section 3. Our cost estimation includes for removal of the existing filtration media and replacement with like kind. The Association should confirm their maintenance and renovation responsibility with the City of Austin.

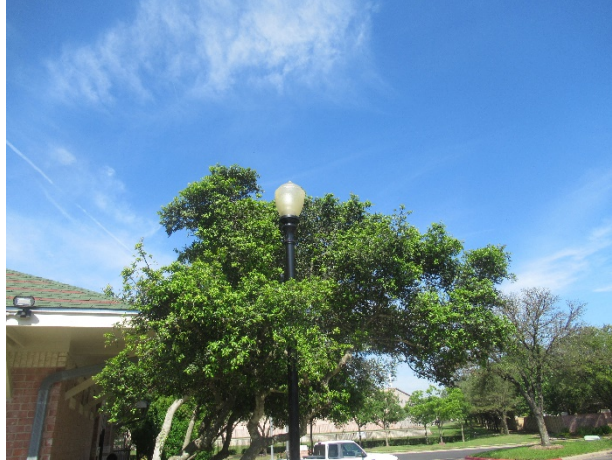
Condition: Good to fair overall

Light pole and fixture

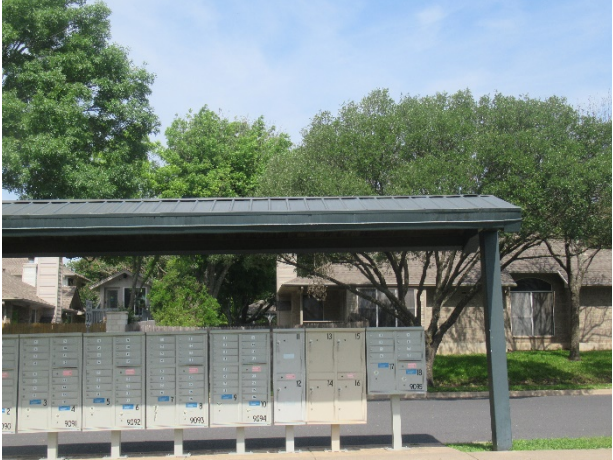
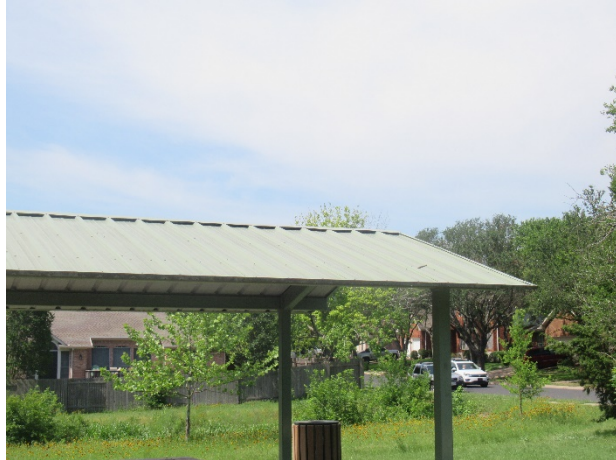
Condition: Good to fair overall

Overview of mailbox kiosk roof

Metal roof

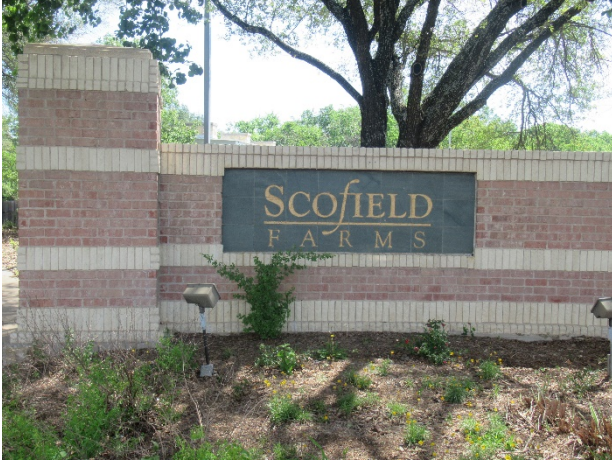
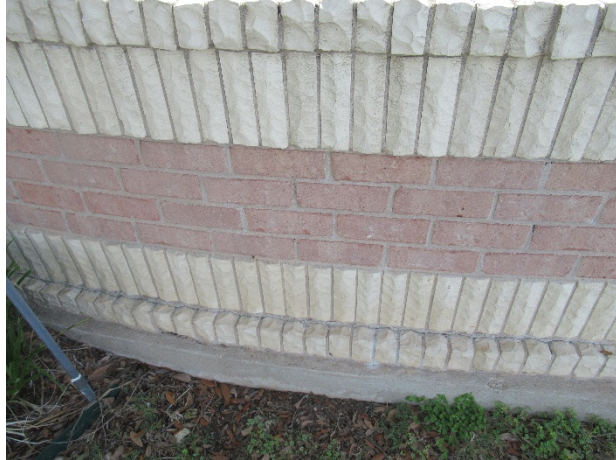
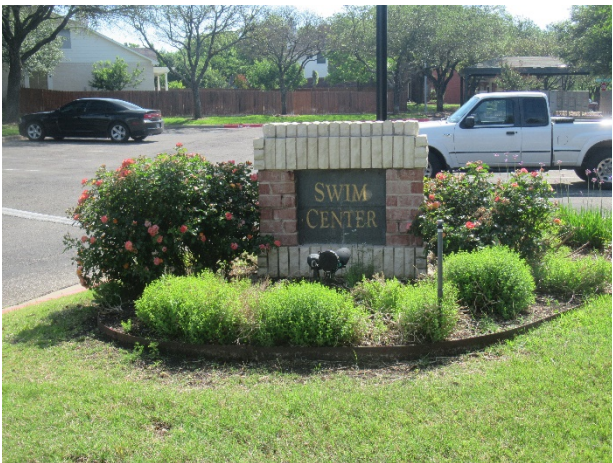
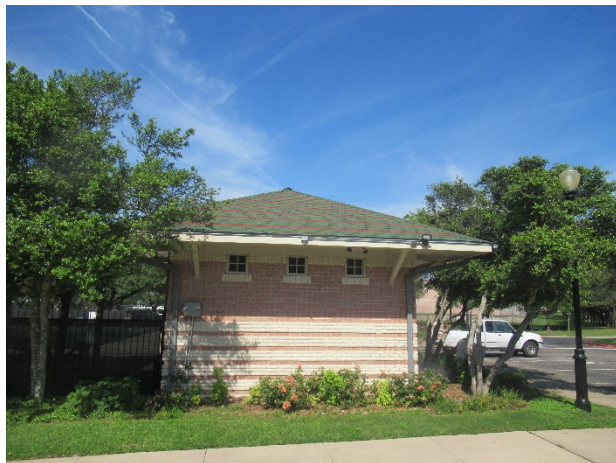
Condition: Good to fair with minor mortar deterioration

Overview of masonry at monument

Masonry at monument

Monument at pool house

Pool house masonry

Expenditure Detail Notes: Expenditure timing and costs are depicted in the **Reserve Expenditures** table in Section 3. We recommend the Association budget for up to five percent (5%) repointing of the masonry and up to one percent (1%) replacement.

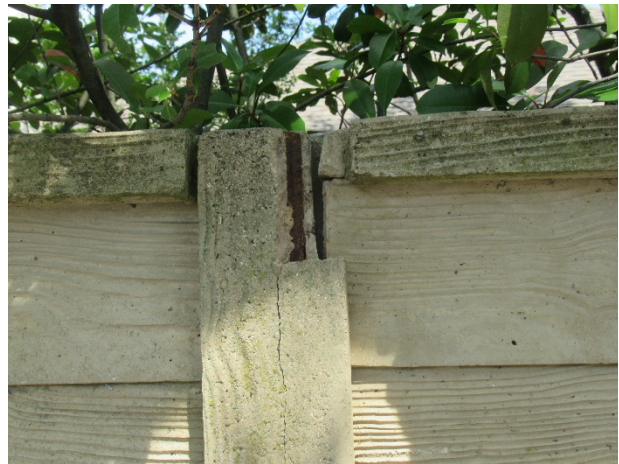
Condition: Good to fair overall with areas of concrete deterioration and exposed reinforcement steel

Exposed reinforced steel

- As-needed:
 - Inspect for significant damage, spalling and cracks. If these conditions exist, perform near term repairs and remediation, utilizing reserve funds if project scope warrants.
 - Ensure irrigation heads are directed away from the walls and tree roots do not undermine the support columns

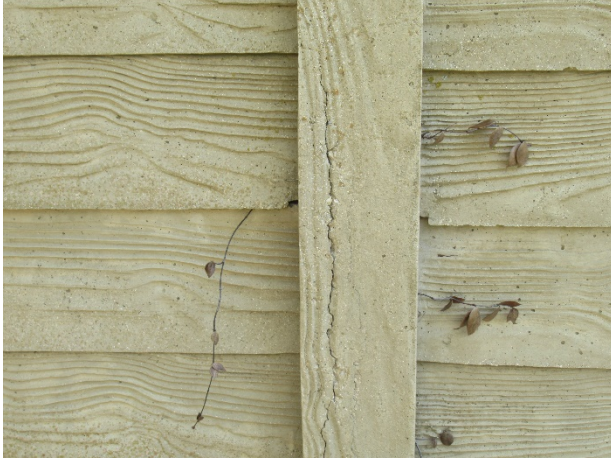
Concrete column crack

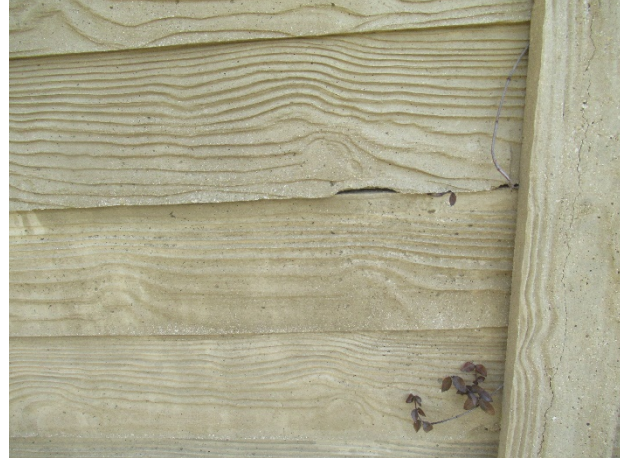
Minor deteriorated concrete

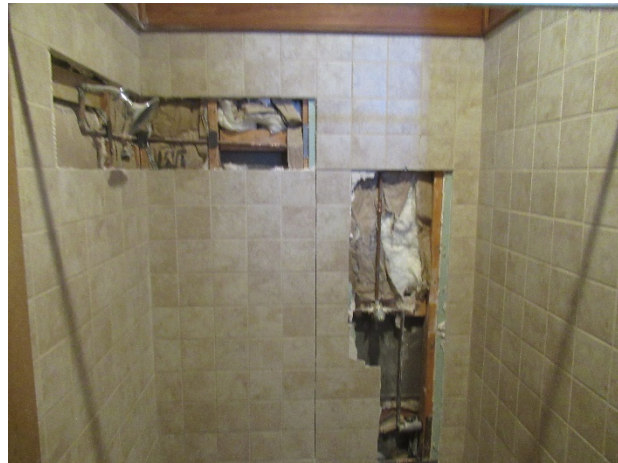
History: Components are mostly original with repairs performed due to damaged pipes during cold weather

Repairs being performed to pipes

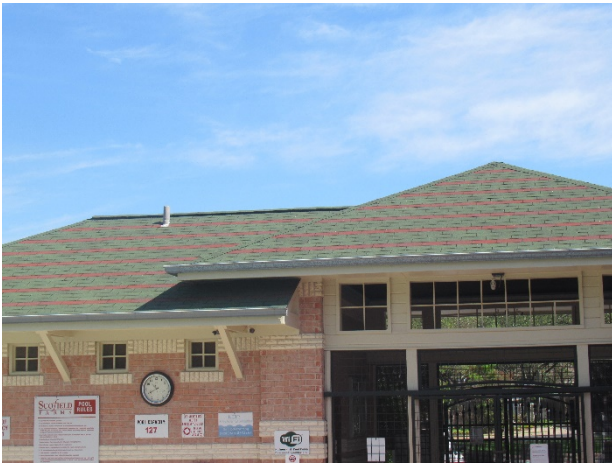
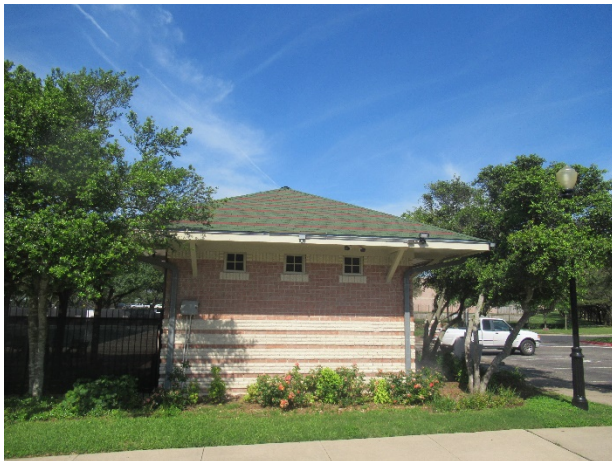
Condition: Fair overall with shingle lift evident

Pool house roof

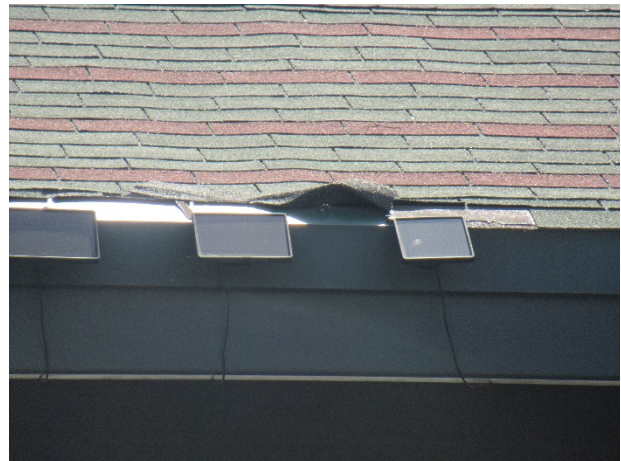
Shingle lift

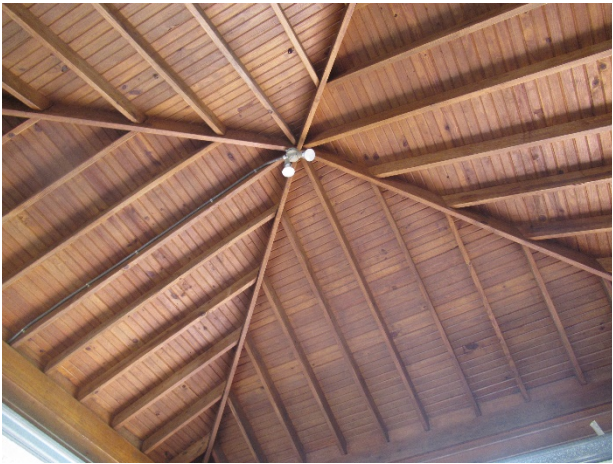
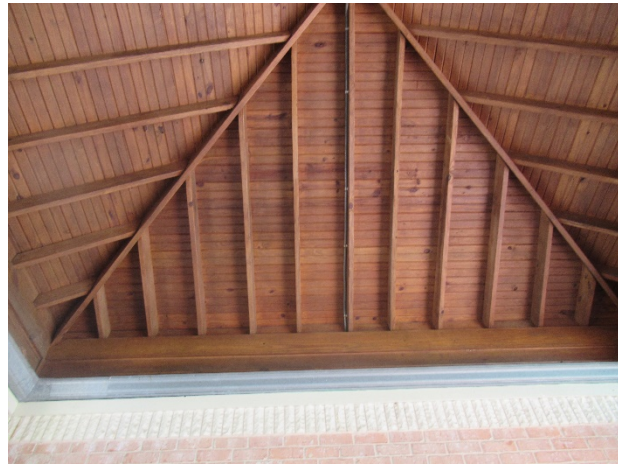
Condition: Good to fair overall

Soffit area

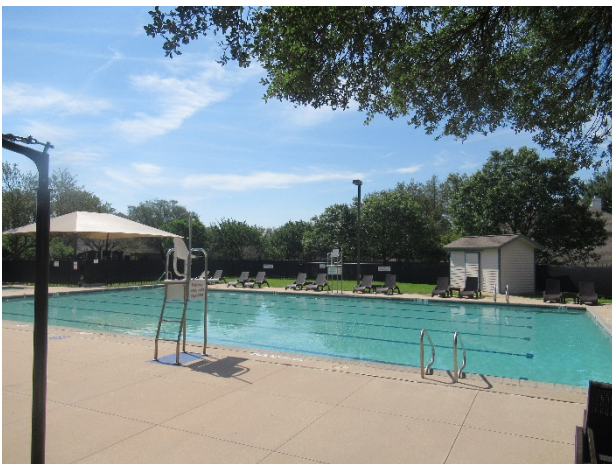
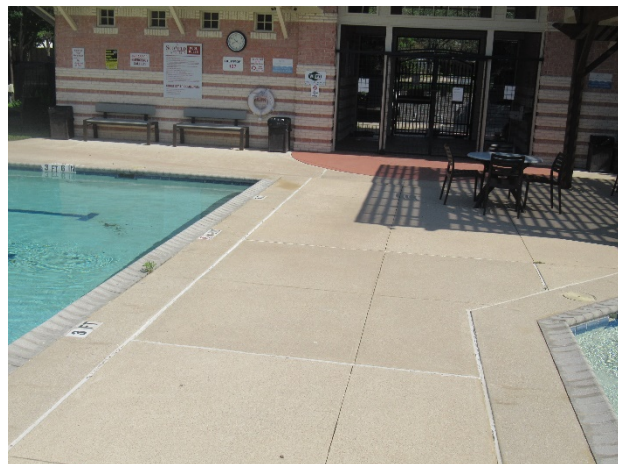
Condition: Good to fair overall condition with isolated cracks

Overview of pool and deck

Concrete deck

Useful Life: The useful life of a concrete pool deck is up to 60 years or more with timely repairs. We recommend the Association conduct inspections, partial replacements and repairs to the deck every 8- to 12-years.

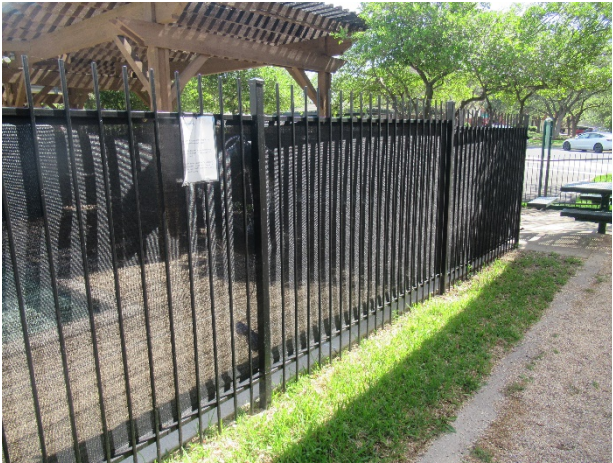
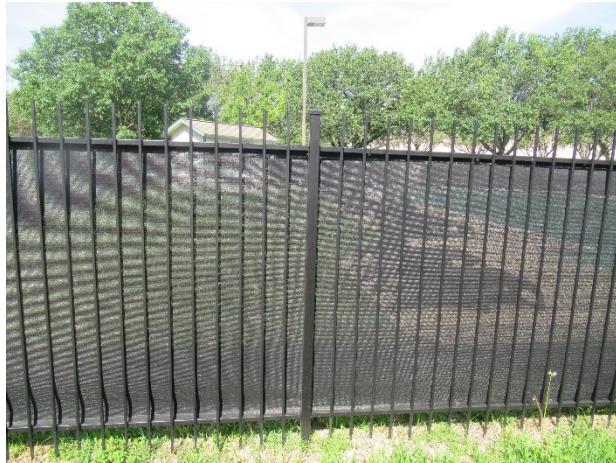
Condition: Good to fair overall with isolated paint finish deterioration

Aluminum fence
